*Some engineering problems of the
Panama canal in their relation to ...*

Donald Francis MacDonald

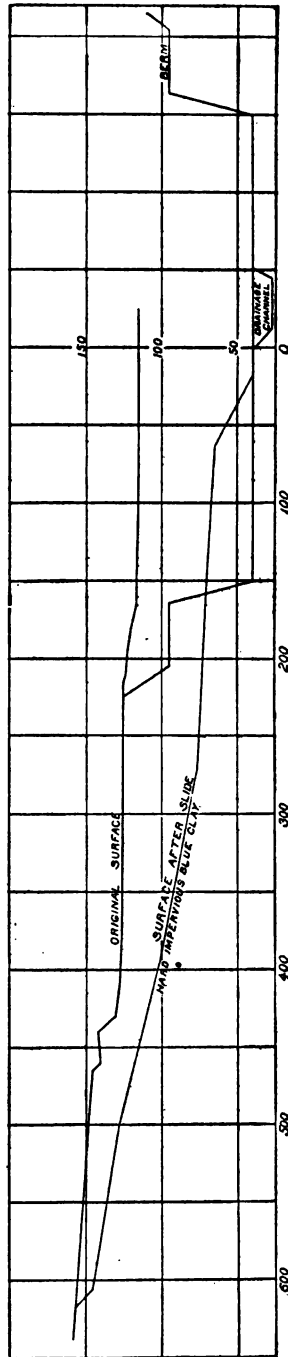
FIGURE 9.—Cross section of slide shown in Plate XXII.

The third type of slide was that occasioned primarily by sheared and weakened zones in the rocks, due to fault displacements. As the rock masses moved past each other, in the adjustment of earth blocks in late geologic time, the frictional pressure or drag was often great enough to crush and shear the material for several feet on each side of the plane of movement (Pls. XV, XIX, XX, and XXV). Where faults of this kind cut diagonally across the canal large masses of rock in the acute angle between the fault plane and the plane of the canal slope generally fell out into the excavation. Where the fault plane had a considerable dip it left a mass of rock, with a narrow base and wide top, resting insecurely against

the slippery crushed rock of the fault zone and quite separated by this crushed material from the solid rock on the other side of the break. This development, of course, threw an extra strain on the base of the faulted-off mass, and if that failed, the whole block crushed down.
